Army Lodging Wellness Recommendation

Final Submittal - Carlisle Barracks

February 20, 2004

Section 1 Wellness Recommendation

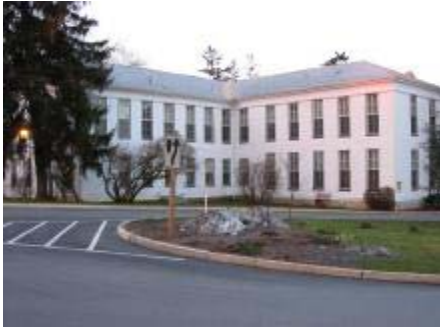
*Building 7
7 Ashburn Dr.
Carlisle Barracks, Pa.*

Building 7, constructed in 1888, is a historical 2-story wood structure which received major renovations in 1988 and in 2001. The building has 10 existing standard rooms and 4 family suites. Although these facilities were recently renovated, they do not meet Lodging size requirements or provide appropriate support spaces and cannot be reconfigured without significant reconstruction. To renovate Building 7 to the new standards and configuration will exceed 50% of the replacement cost.

• Renovation Cost	\$1,132,366
• Replacement Cost	\$1,629,482
• Renovation to Replacement Cost Ratio	69.49%

Because the Renovation to Replacement Cost Ratio is greater than 50.00%, renovation of Building 07 is not recommended.

Our recommendation is to remove building 7 from the Lodging inventory, allowing the installation to determine an alternate use for this facility. This facility will be removed from the Carlisle Barracks Wellness Solution and Lodging Master Plan.

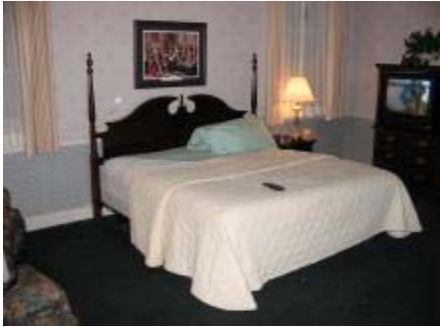
Building 7
Typical Bedroom

- Analysis: The hard goods consist of a headboard, night stand, dresser, easy chair, fabric covered side chair, desk, and entertainment unit. The soft goods consist of drapes and shear drapes on the windows, TV, mattress and box springs and bed coverings. All are in good condition. The majority of the goods were installed before 1998 and should be replaced by 2008.
- Recommendation: Replace all hard goods and soft goods in the guest rooms.

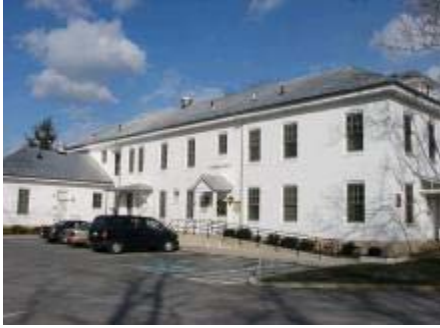
*Building 36
36 Flower Rd.
Carlisle Barracks, Pa.*

• Condition Assessment & Upgrade Cost	\$368,676
• Replacement Cost	\$2,523,495
• Condition Assessment & Upgrade to Replacement Cost Ratio	14.61%

Because the Sum of the Condition Assessment and Upgrade Costs to Replacement Cost Ratio is less than 50.00%, repair, upgrade, and continued use of Building 36 is recommended.

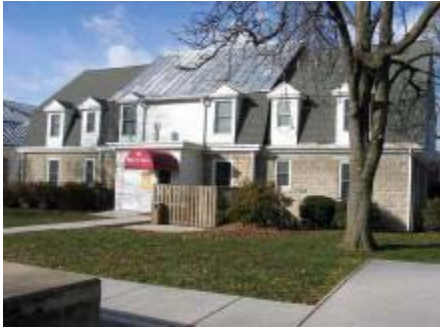
*Building 37
37 Garrison Lane
Carlisle Barracks, Pa.*

• Condition Assessment & Upgrade Cost	\$224,449
• Replacement Cost	\$1,168,502
• Condition Assessment & Upgrade to Replacement Cost Ratio	19.21%

Because the Sum of the Condition Assessment and Upgrade Costs to Replacement Cost Ratio is less than 50.00%, repair, upgrade, and continued use of Building 37 is recommended.
